Re: Notice of Violation
RCRA Compliance Evaluation Inspection
Elite Coatings, Inc.
EPA I.D. No.: WIR000107128

RCRA COMPLIANCE EVALUATION INSPECTION REPORT

SITE NAME: Elite Coatings, Inc.

DATE OF INSPECTION: February 25, 2014

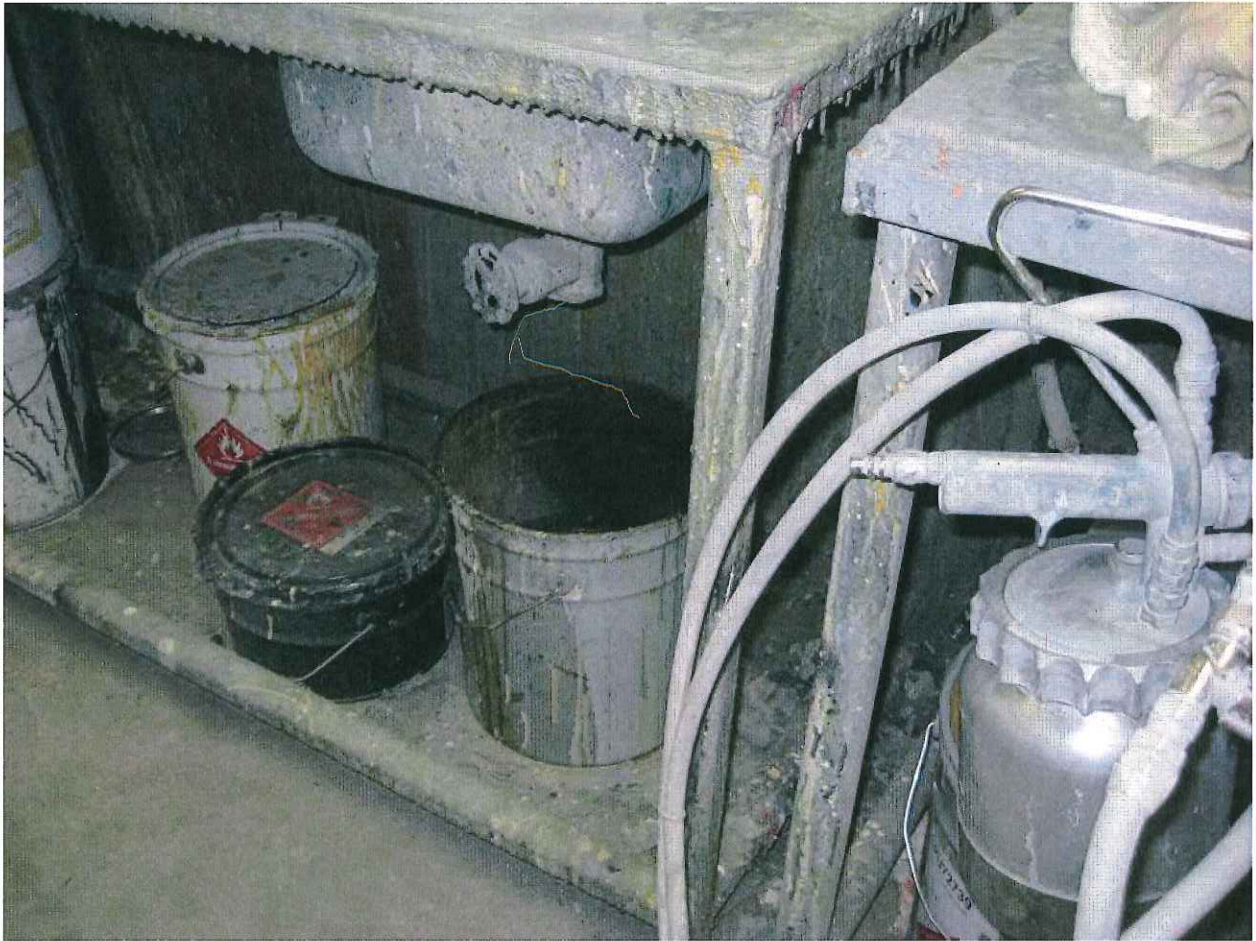
Photograph Number: 1

Photograph Description: Open and unlabeled container accumulating spent solvent under a sink in the mix room area.

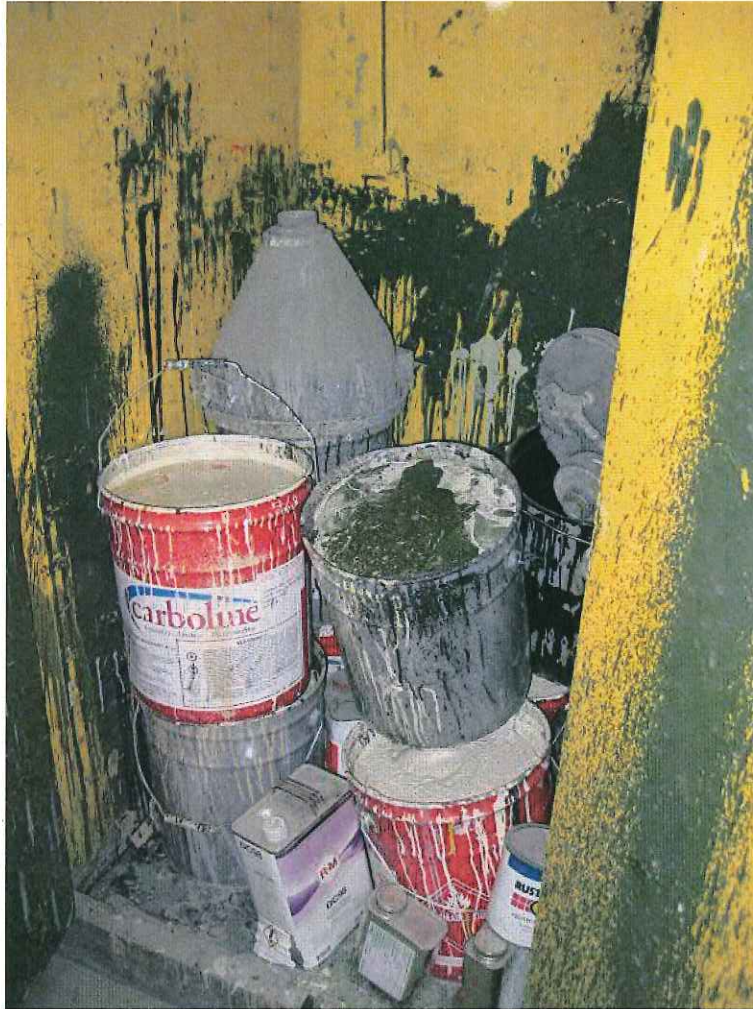
Photograph Number: 3

Photograph Description: Contents of a fireproof locker next to the mix room accumulating containers (5-gallon pails) with drying activated paint. Smaller containers of unknown disposition.

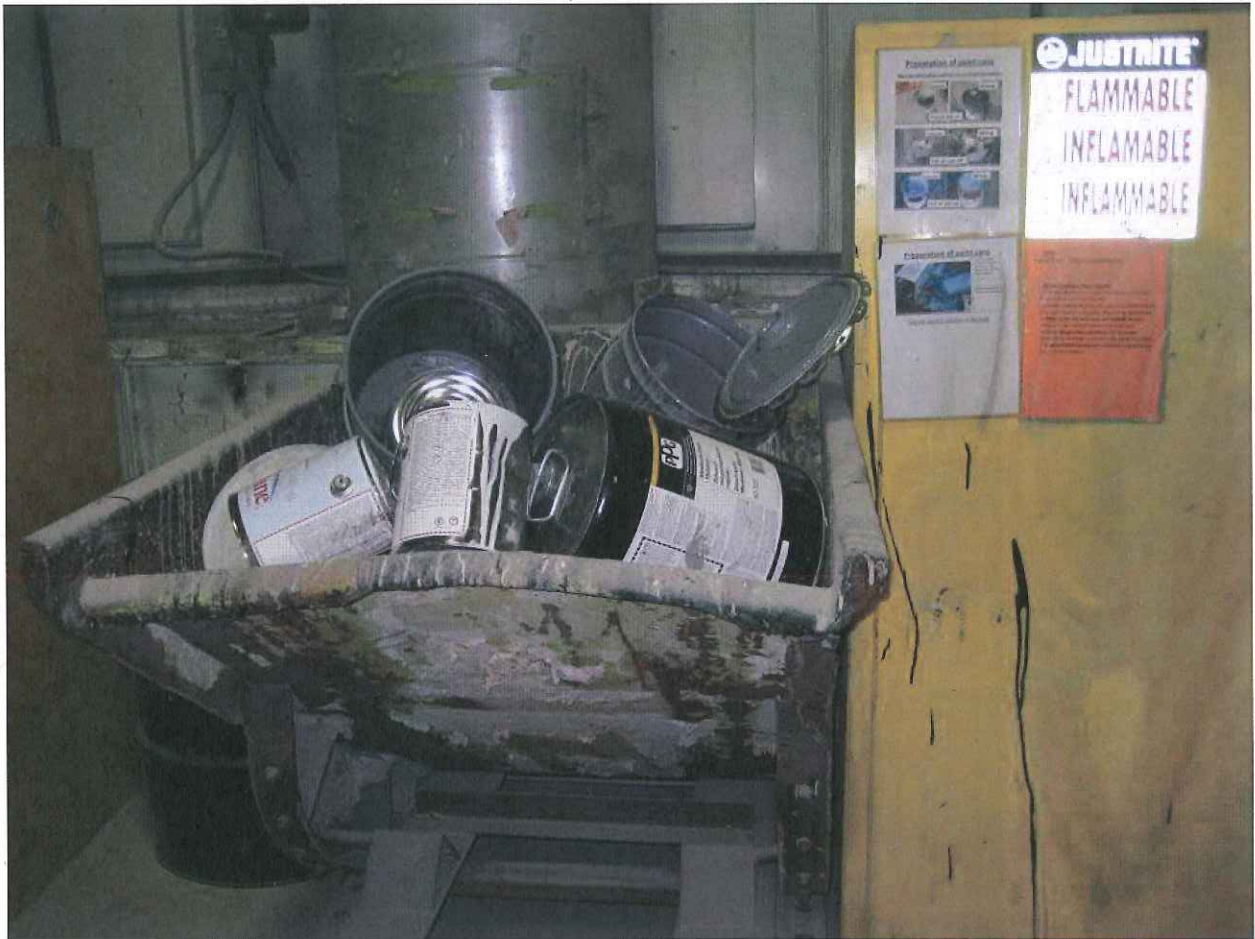
Photograph Number: 4

Photograph Description: Metal container recycling area next to the paint room.

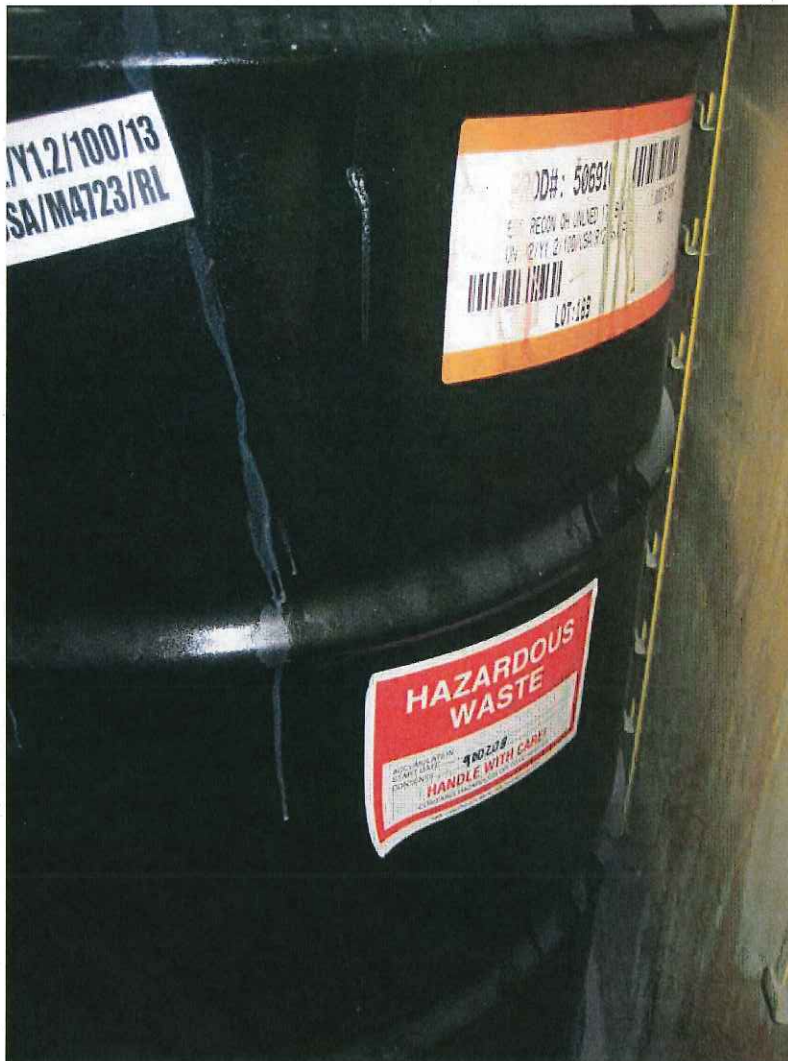
Photograph Number: 5

Photograph Description: 180-day drum accumulating solvent recycling bottoms with missing accumulation start date located in a fireproof locker next to the paint room.

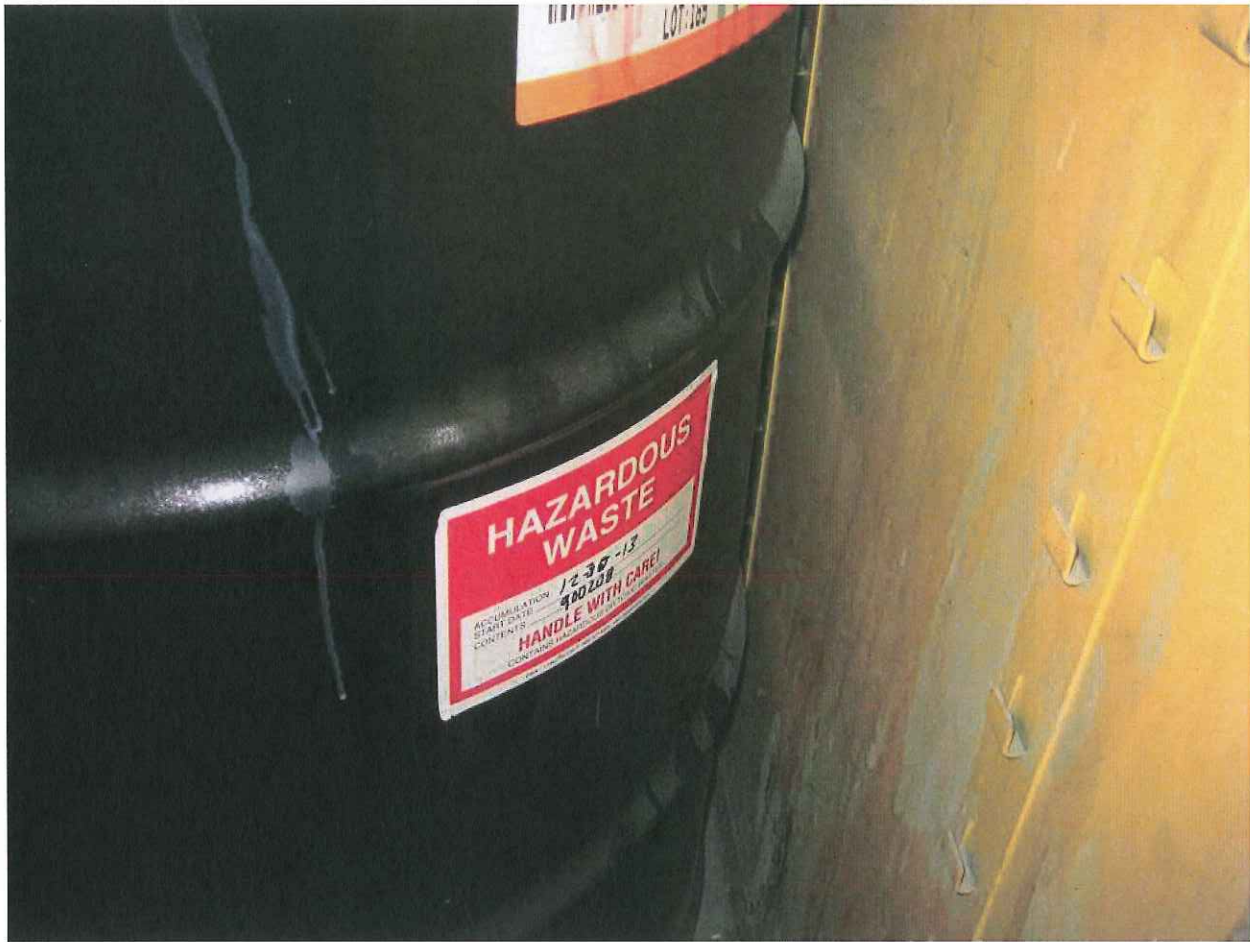
Photograph Number: 6

Photograph Description: 180-day 55-gallon drum accumulating solvent recycling bottoms dated with accumulation start date; previously pictured in photo 5.

5. In order to avoid the need for a hazardous waste storage permit, a small quantity generator using accumulation containers must mark each container with the accumulation start date. See, ss. NR 662.192(1)(d)(1). [40 CFR §§ 262.34(d)(4), 262.34(a)(2)]. At the time of the inspection, Elite Coatings failed to date a 55-gallon container accumulating spent solvent bottoms near ink room with the accumulation start date. Elite Coatings, therefore, failed to comply with the above-mentioned condition for a storage license exemption. However, during the inspection, Elite Coatings employee wrote the 12/30/2013 accumulation start date on the container.
